RECLAMATION DISTRICT NO. 828
WEBER TRACT
BOARD OF TRUSTEES MEETING
FRIDAY, MAY 13, 2016
8:30 AM
ENGINEER'S REPORT

FILE MEMORANDUM

To: Chris Neudeck, PE
Subject: Follow-Up Inspection
Project: Weber Tract Public Outreach
From: Aaron Lickingteller

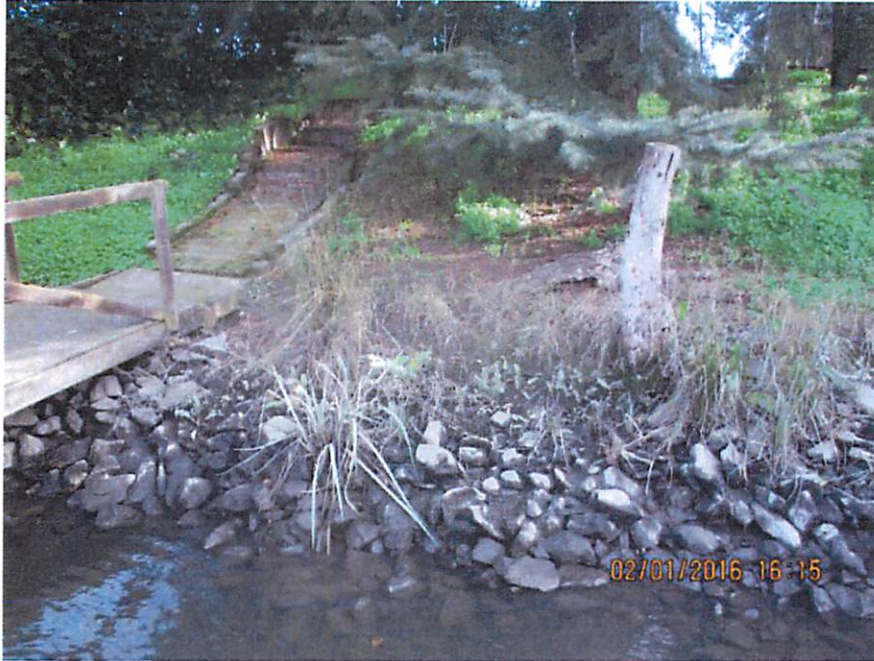
- I arrived at said address at 3:00 pm and met Daniel Moore at the door. He led me through his house into the backyard and onto the levee in his backyard for inspection. His only concerns were that during high tides, the water in the canal reaches a level higher up on the levee embankment than the current level of existing rip rap (approximately a foot or less higher than the current rip rap elevation). There appeared to be one varmint hole approximately one foot above the rip rap and next to the gangway for his dock. Daniel also mentioned that, in the summer, the waterside levee embankment cracks approximately halfway up the waterside levee slope. No cracks were evident on the day of the visit, probably due to rain saturation of the levee embankment soil causing swell to fill them in temporarily, according to Daniel.

The waterside levee embankment on the Moore's property. Daniel stated that the high tide reaches the foot of the wooden gangway upslope from the rip rap.

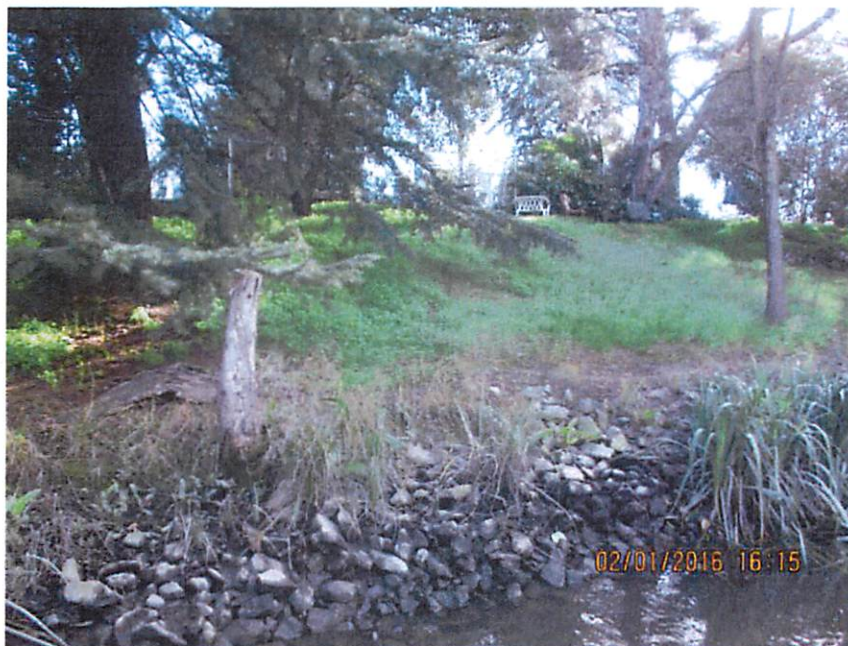
The vegetated portion of the levee embankment shown in the photo, and to the right of the trees in the foreground, cracks due to lack of moisture. Recent rains have left no evidence of cracking.

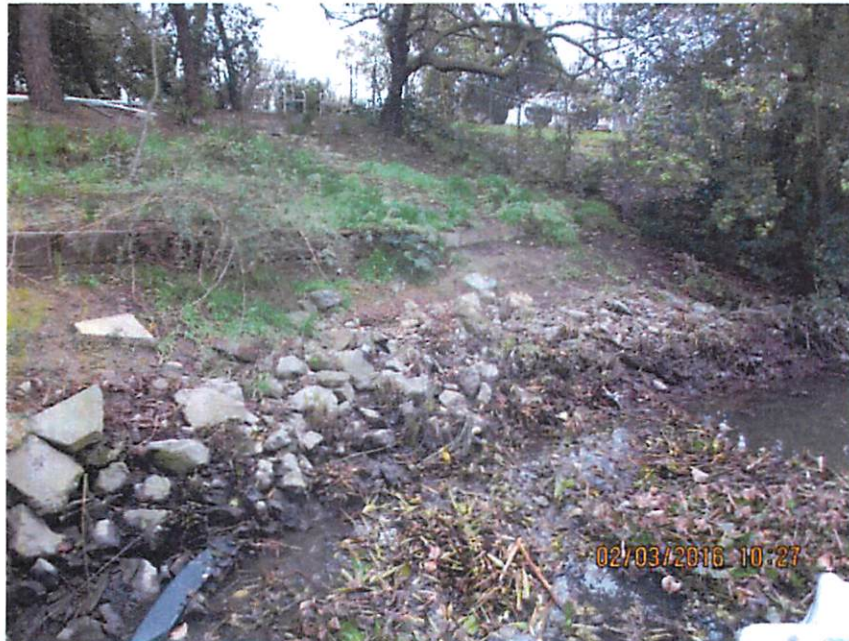
- I arrived at said address at the prescheduled time of 9:00 am and Brandon Marino escorted me to the levee in the backyard of his property for an inspection. The tide was at its 'high' low for the day. I did not see erosion producing any vertical slope, as stated in Mr. Marino's letter of concern. According to Mr. Marino, the high tides produce water surface elevations higher than that of the rip rap currently existing on the bank of his waterside property. He did state that he has seen 'beaver like critters' wandering around on his bank from time to time but I did not see any evidence of burrows at this time.

Water hyacinth near the levee embankment of the Marino property.

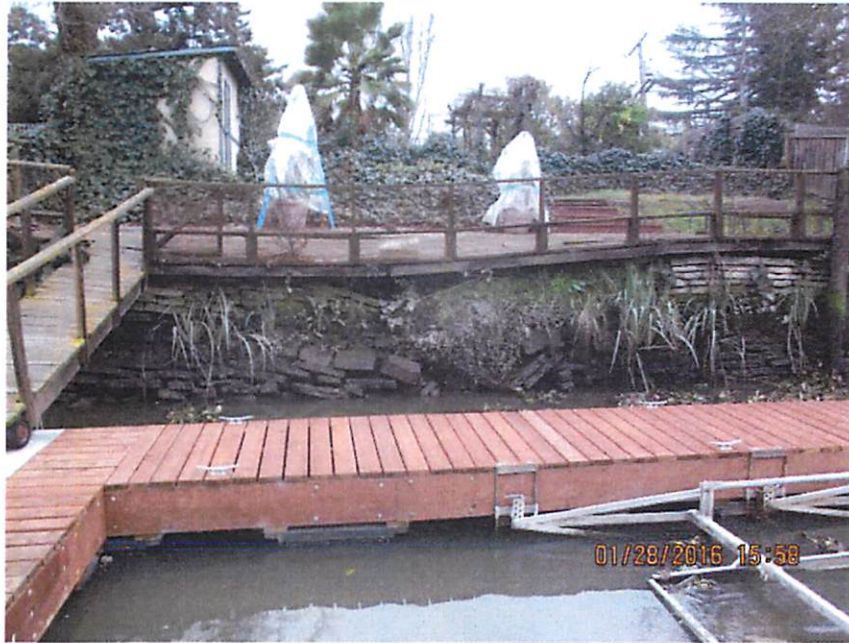
- I visited the residence of Russell and Veniz Richenberg at 1641 West Walnut Street in Stockton, CA 95203 to follow-up on a questionnaire inquiring about potential levee damage on the property. I met Russell in the driveway upon my arrival and his wife, Veniz, accompanied me on an inspection of the waterside levee on her property. Upon reaching the levee crown, I observed a caved-in deck that had apparently sunk in the middle due to erosion beneath. Veniz and I walked across the sunken deck, and down the gangway onto the dock below to gain a better view of the levee beneath the deck. I looked into the gap between the rock-facing above the rip rap that held the wooden deck up in this location and it appeared the rip rap had sunk due to erosion of the underlying soil. After the inspection, I talked with both of the property owners and they informed me that the rip rap had moved from erosion following the winter of 1997-1998, when higher than normal rainfall occurred throughout the area causing flood levels reaching nearly to the levee crown.

The rock facing atop the rip rap on the waterside levee of the Richenberg residence. Peering through the hole showed nothing but rip rap that appeared to have settled due to erosion of the underlying soil. Note the sagging of the wooden deck as a consequence of the eroded rock-facing.

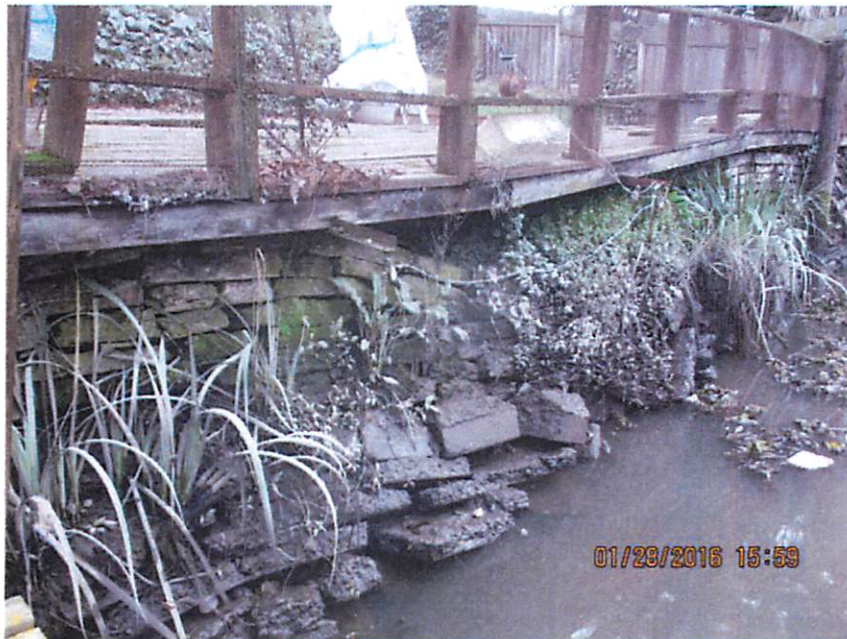
A closer view of the eroded rock-facing. The photo was taken shortly after the low tide of the day.

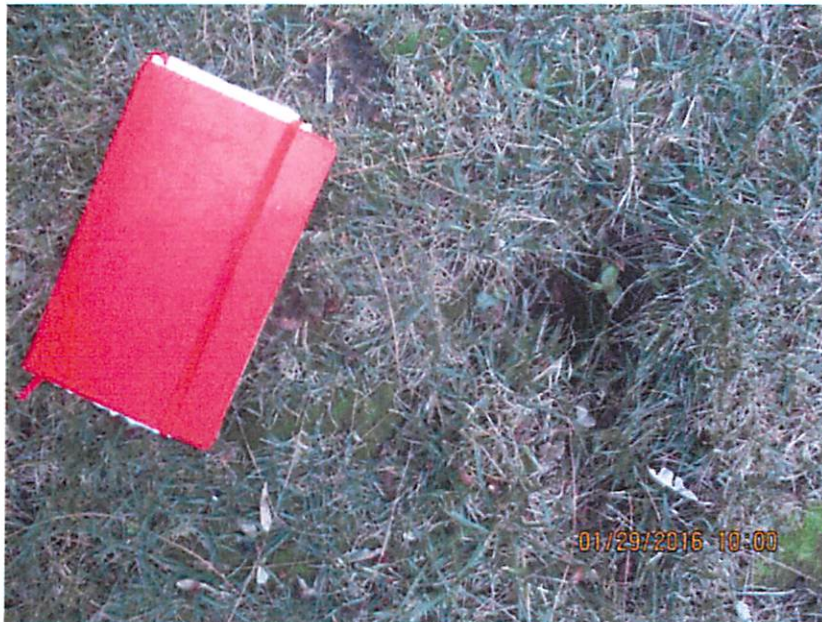
- I visited The Donaldson residence at the address mentioned above to perform a follow-up on a returned questionnaire sent out by KSN asking the landowners to identify any deficiencies in the levees on their property. I met Michael Donaldson in his driveway and he accompanied me to the areas in his back yard where varmint holes existed near the crown of the levee on his property. Only one hole existed in the northeastern quadrant of his property near the tree in that location. He stated that the varmint hole has been a returning problem over the years since he has lived in the area (since 1978) after he fills the hole in with dirt. According the Michael, he has attempted to remedy this problem at least three times over the years. The hole appears to have been dug by local squirrels.

The single varmint hole near the levee crown in the backyard of the Donaldson residence. The notebook is to show scale.

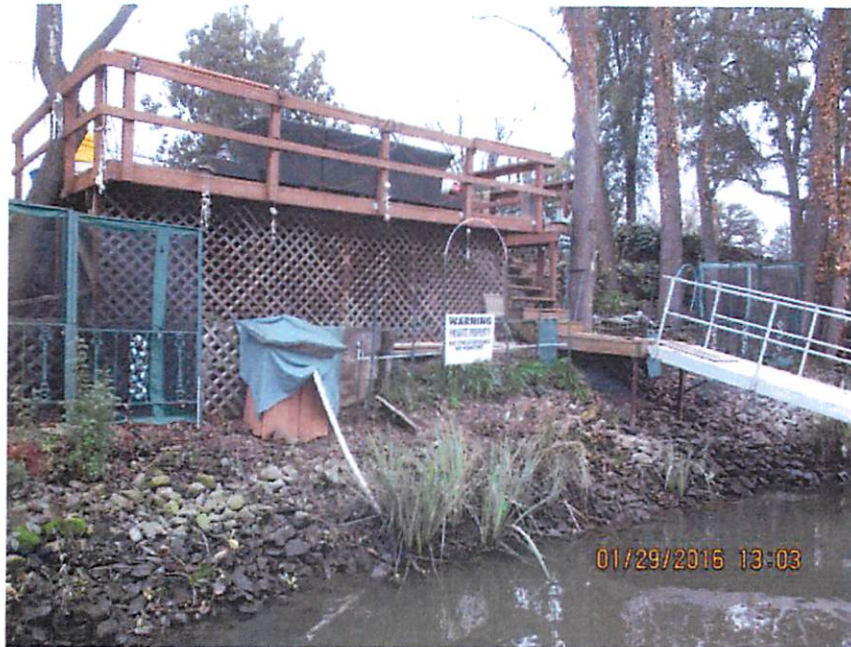
- I met the resident, Randall Schantin, at his driveway at 11:55 am and he accompanied me to the levee located in his backyard for an inspection of the reported deficiencies that he documented on his returned questionnaire. A look at the existing waterside slope of the levee on his property, revealed less than a half dozen spots in the 6-inch minus riprap placed along the water's edge where vegetation had grown through. Mr. Schantin spoke of adding more rock to insure deck and dock safety and I informed him that I was merely a representative of the Levee District and mainly concerned about issues regarding the levee, not the encroachments upon the levee. Higher up the slope, approximately four feet from the crown, an old retaining wall comprised of sheet metal existed. The sheet metal had been pushed northward and rotated until it was touching the ground due to moisturized expansive soils pressing against it or human activity bending it. The tide was not going out but not at its lowest at this time, so inspection below the waterline could not occur except for about 18-inches.

The waterside view of the levee. Conversations with Mr. Schantin revealed that the tides get as far up the bank as the small pump station shown in the middle of the photo.

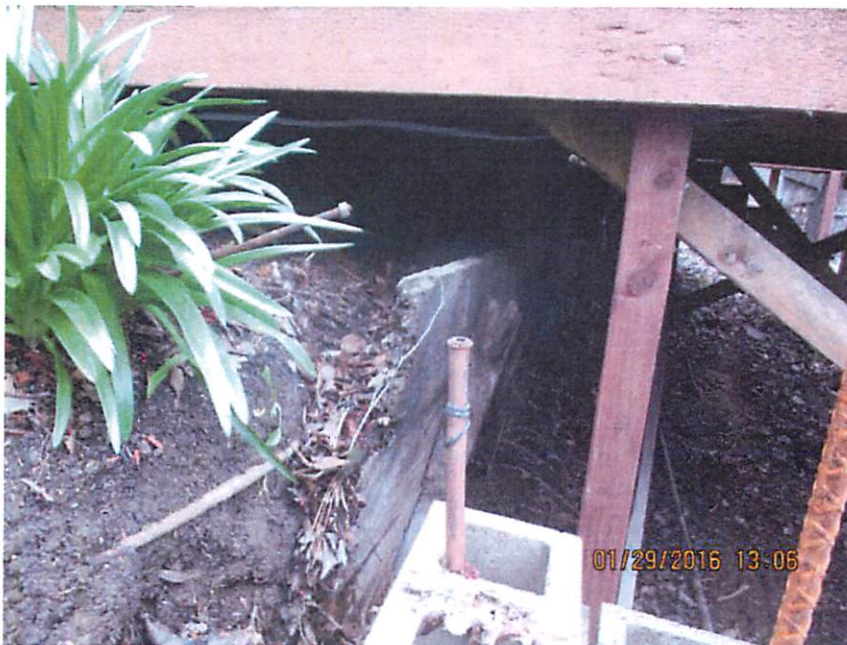
The levee crown appeared to be at the same elevation as the neighbors on both sides of the property in question. However, inspection revealed this 'retaining wall' about 3-feet from the crown along the entire property width.

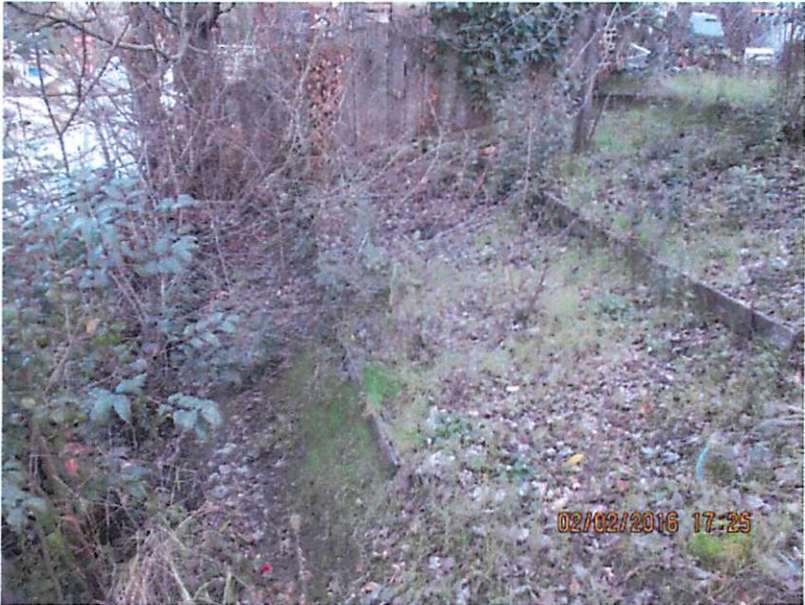
Contractor Work Hours:	N/A to N/A
<ul style="list-style-type: none"> I arrived at the Bird residence at 4:00 pm and Bart Bird accompanied me to the levee in his backyard for an inspection of the levee on his property. Upon inspecting the levee on his property, Bart stated that he frequently sees cracking during the hot summers when he mows the grass on his levee. During my inspection, I saw no cracking, but this was probably due to the recent rains that moisture-conditioned the soil, causing it to expand and fill the cracks back in. No dock or gangway existed in the water on Mr. Bird's property and access to the levee did not provide optimal viewing due to large quantities of brush along his waterside bank. He also said that high tides in the canal result in water elevations higher than the current rip rap elevation.

<p>Areas of the waterside levee embankment where cracking was said to occur in the summer months.</p>
