**RECLAMATION DISTRICT NO. 828
WEBER TRACT
BOARD OF TRUSTEES MEETING
THURSDAY, OCTOBER 21, 2021
8:30 AM
ENGINEER'S REPORT**

FIELD REPORT

OWNER: **Reclamation District No. 828** PROJECT: **Vegetation Control Needs**
CONTRACTOR: **Dino & Son** CONTRACT NO.: [Click here to enter text.](#)
KSN JOB NO.: **1204-9022-04** DATE: **08/30/2021**

OWNER: **Reclamation District No. 828** PROJECT: **Man-Made Boat Ramp**
CONTRACTOR: **n/a** CONTRACT NO.: **n/a**
KSN JOB No: **1204-9022** DATE: **7/20/2021**

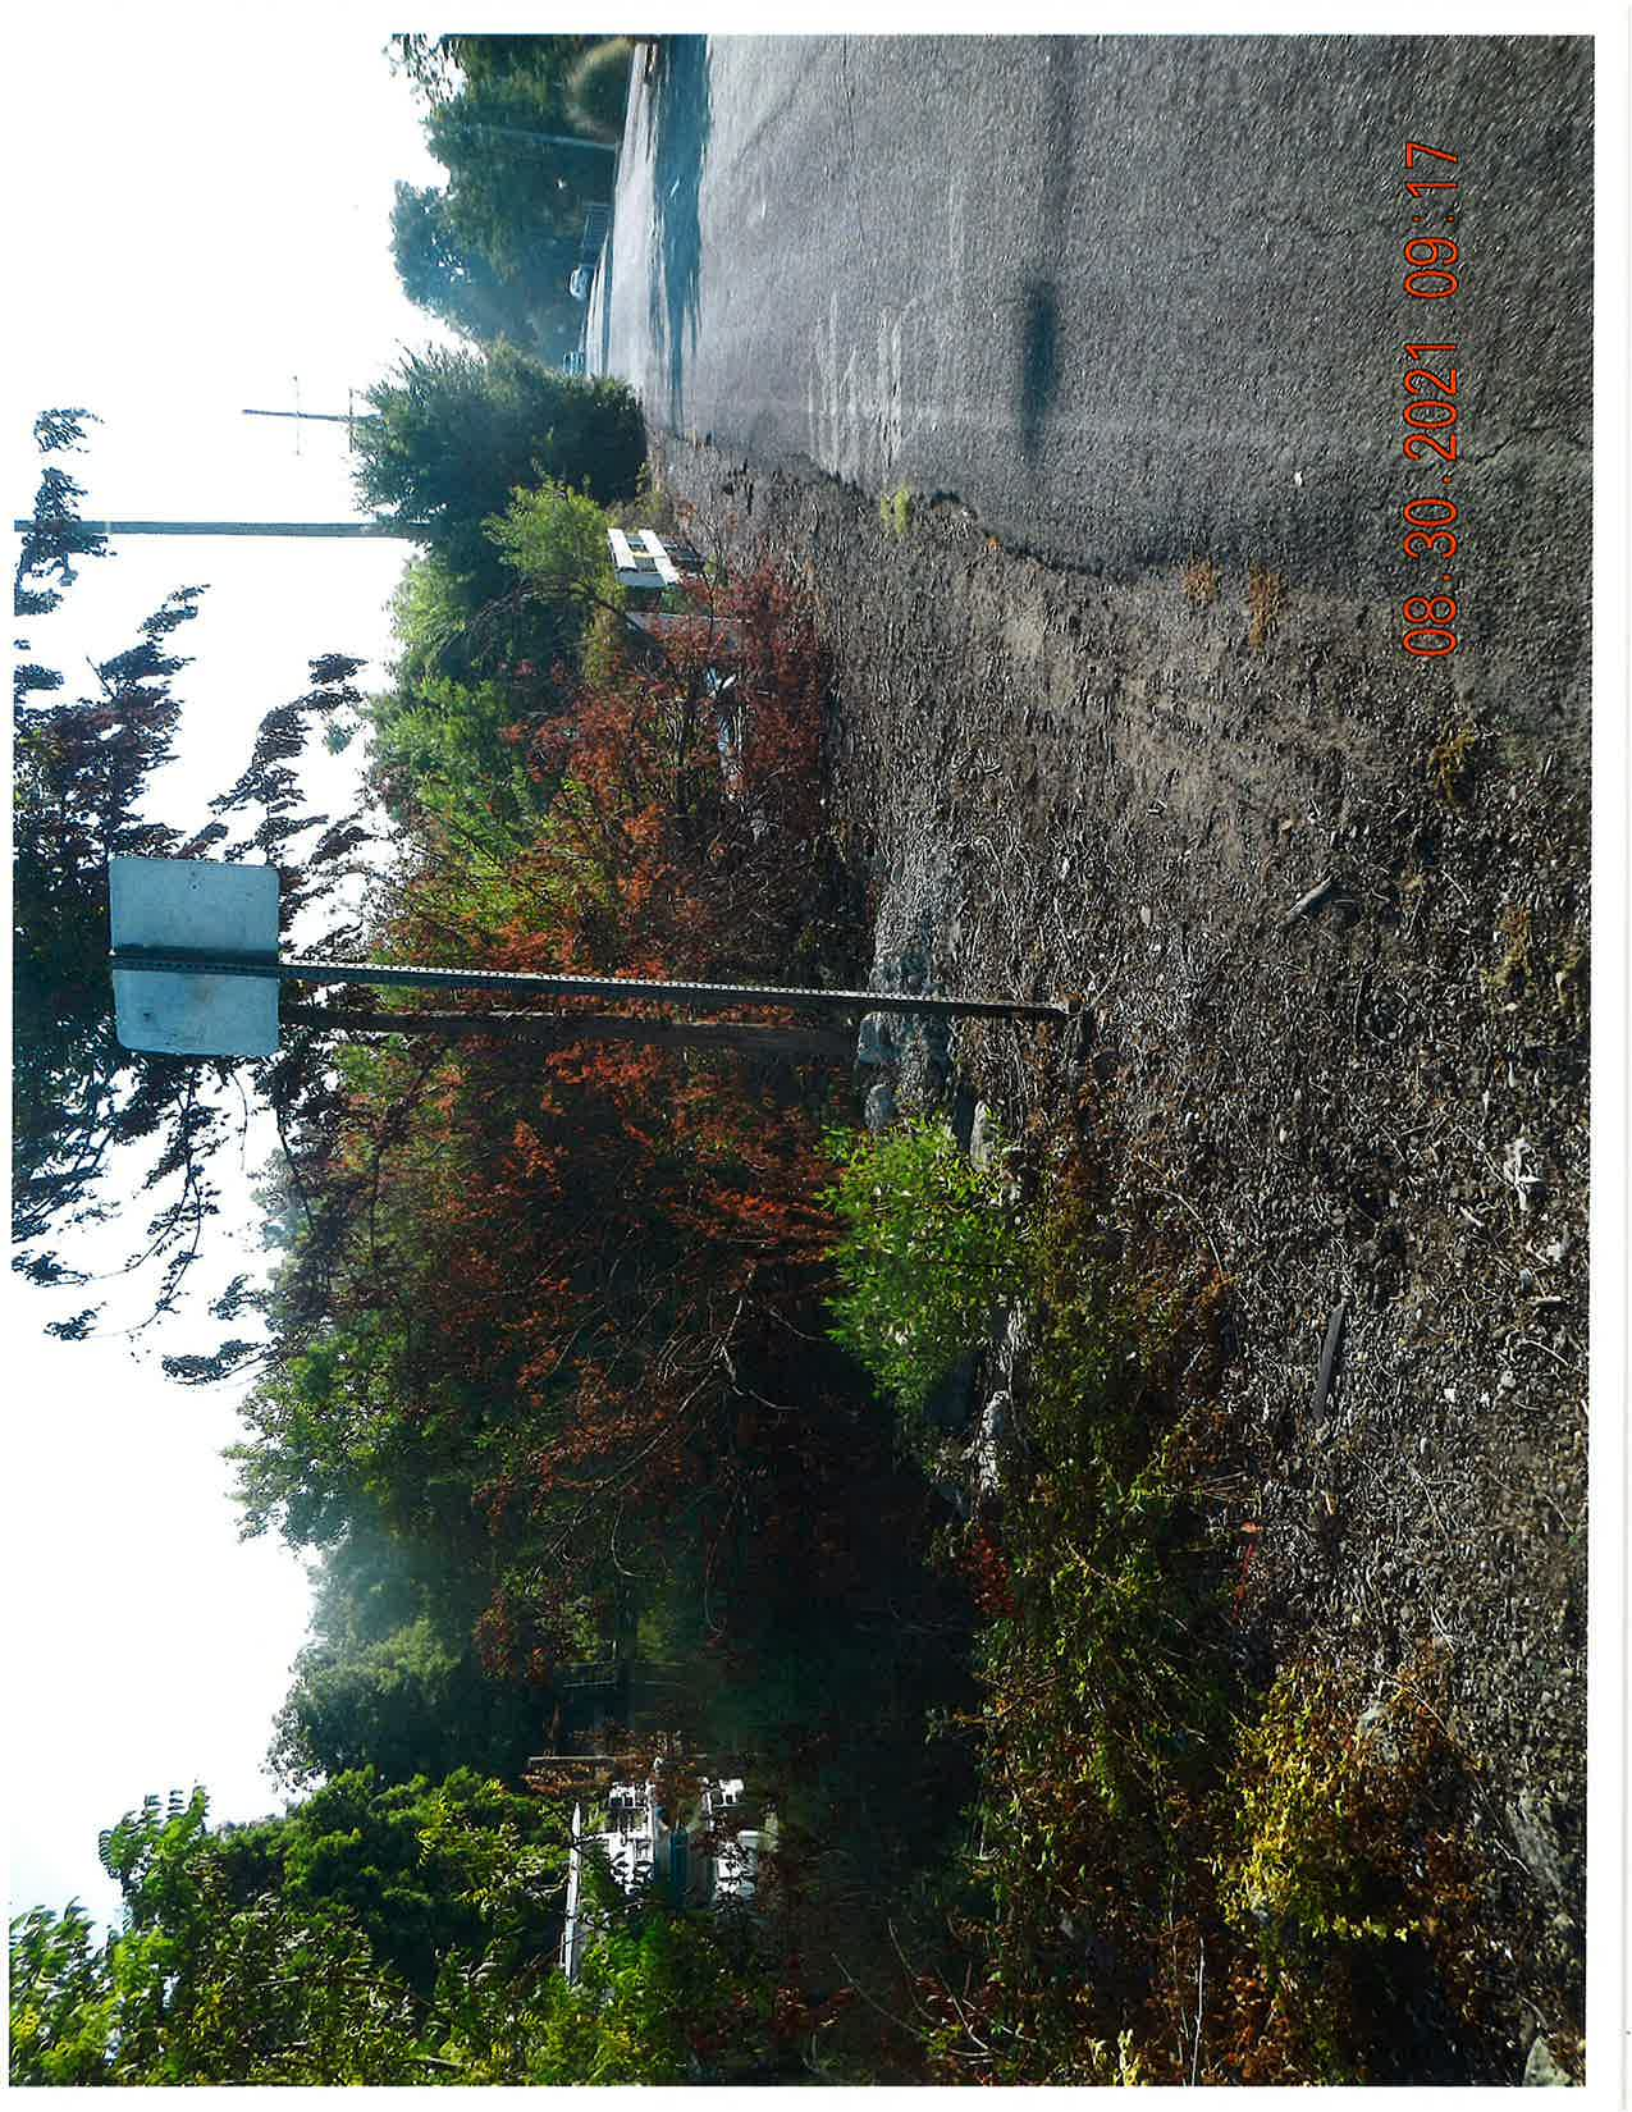
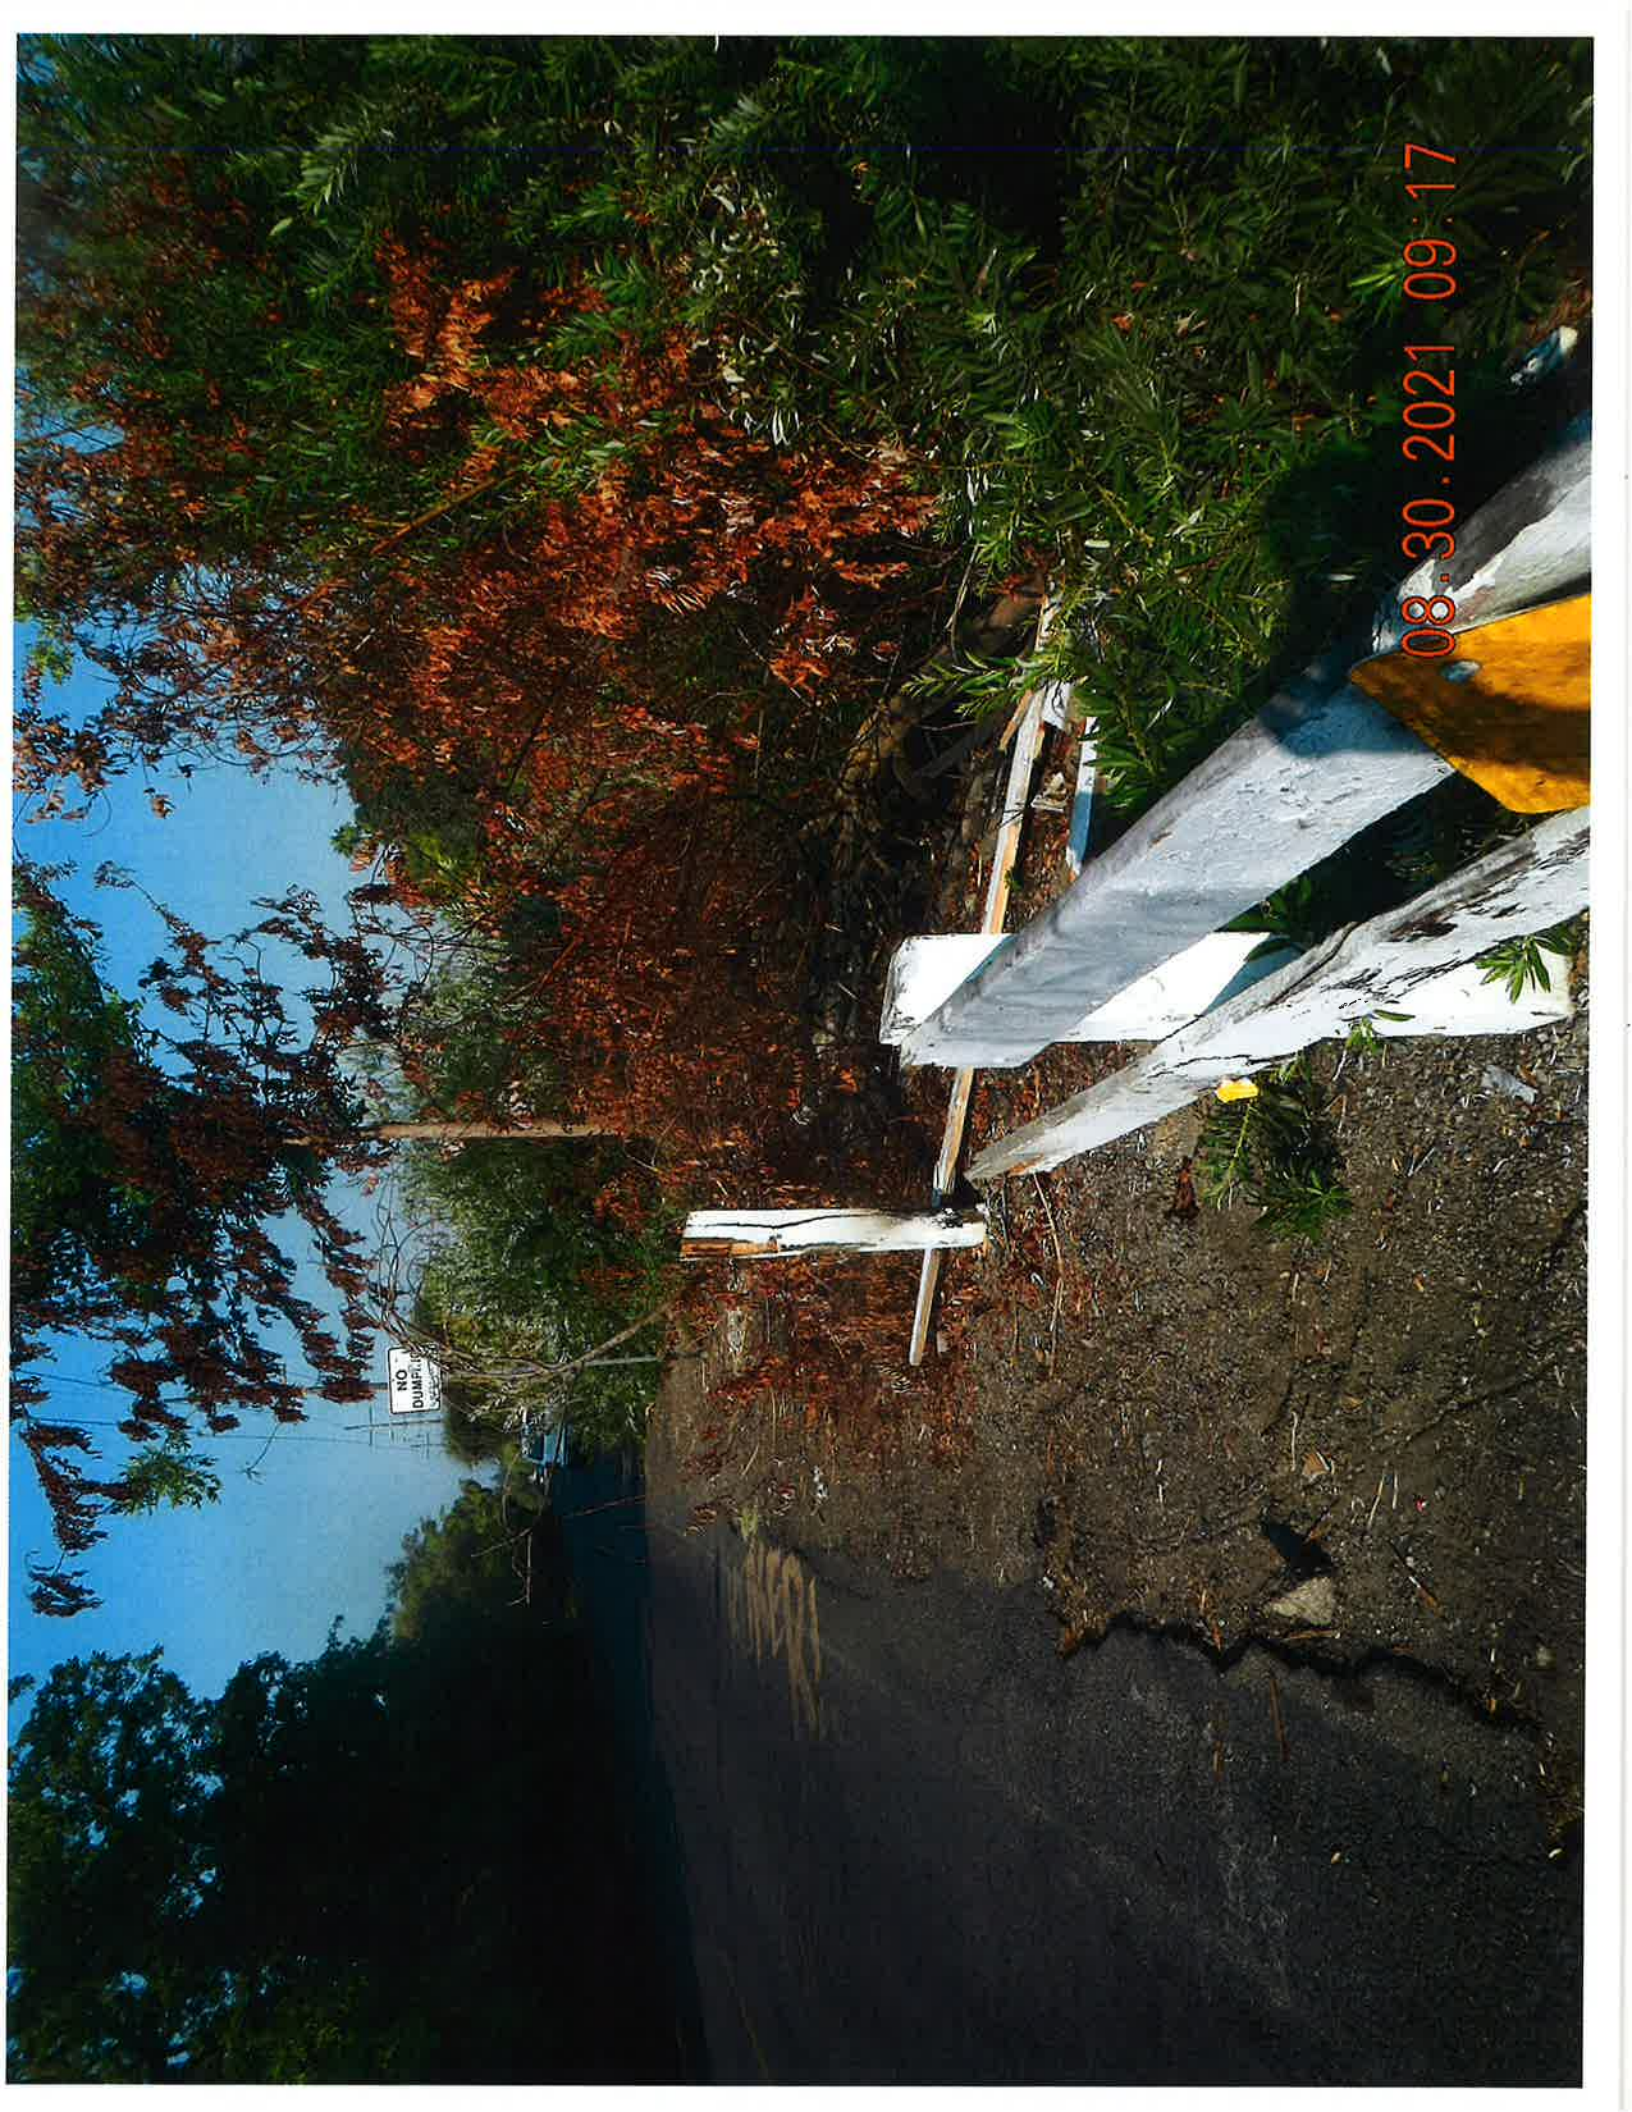
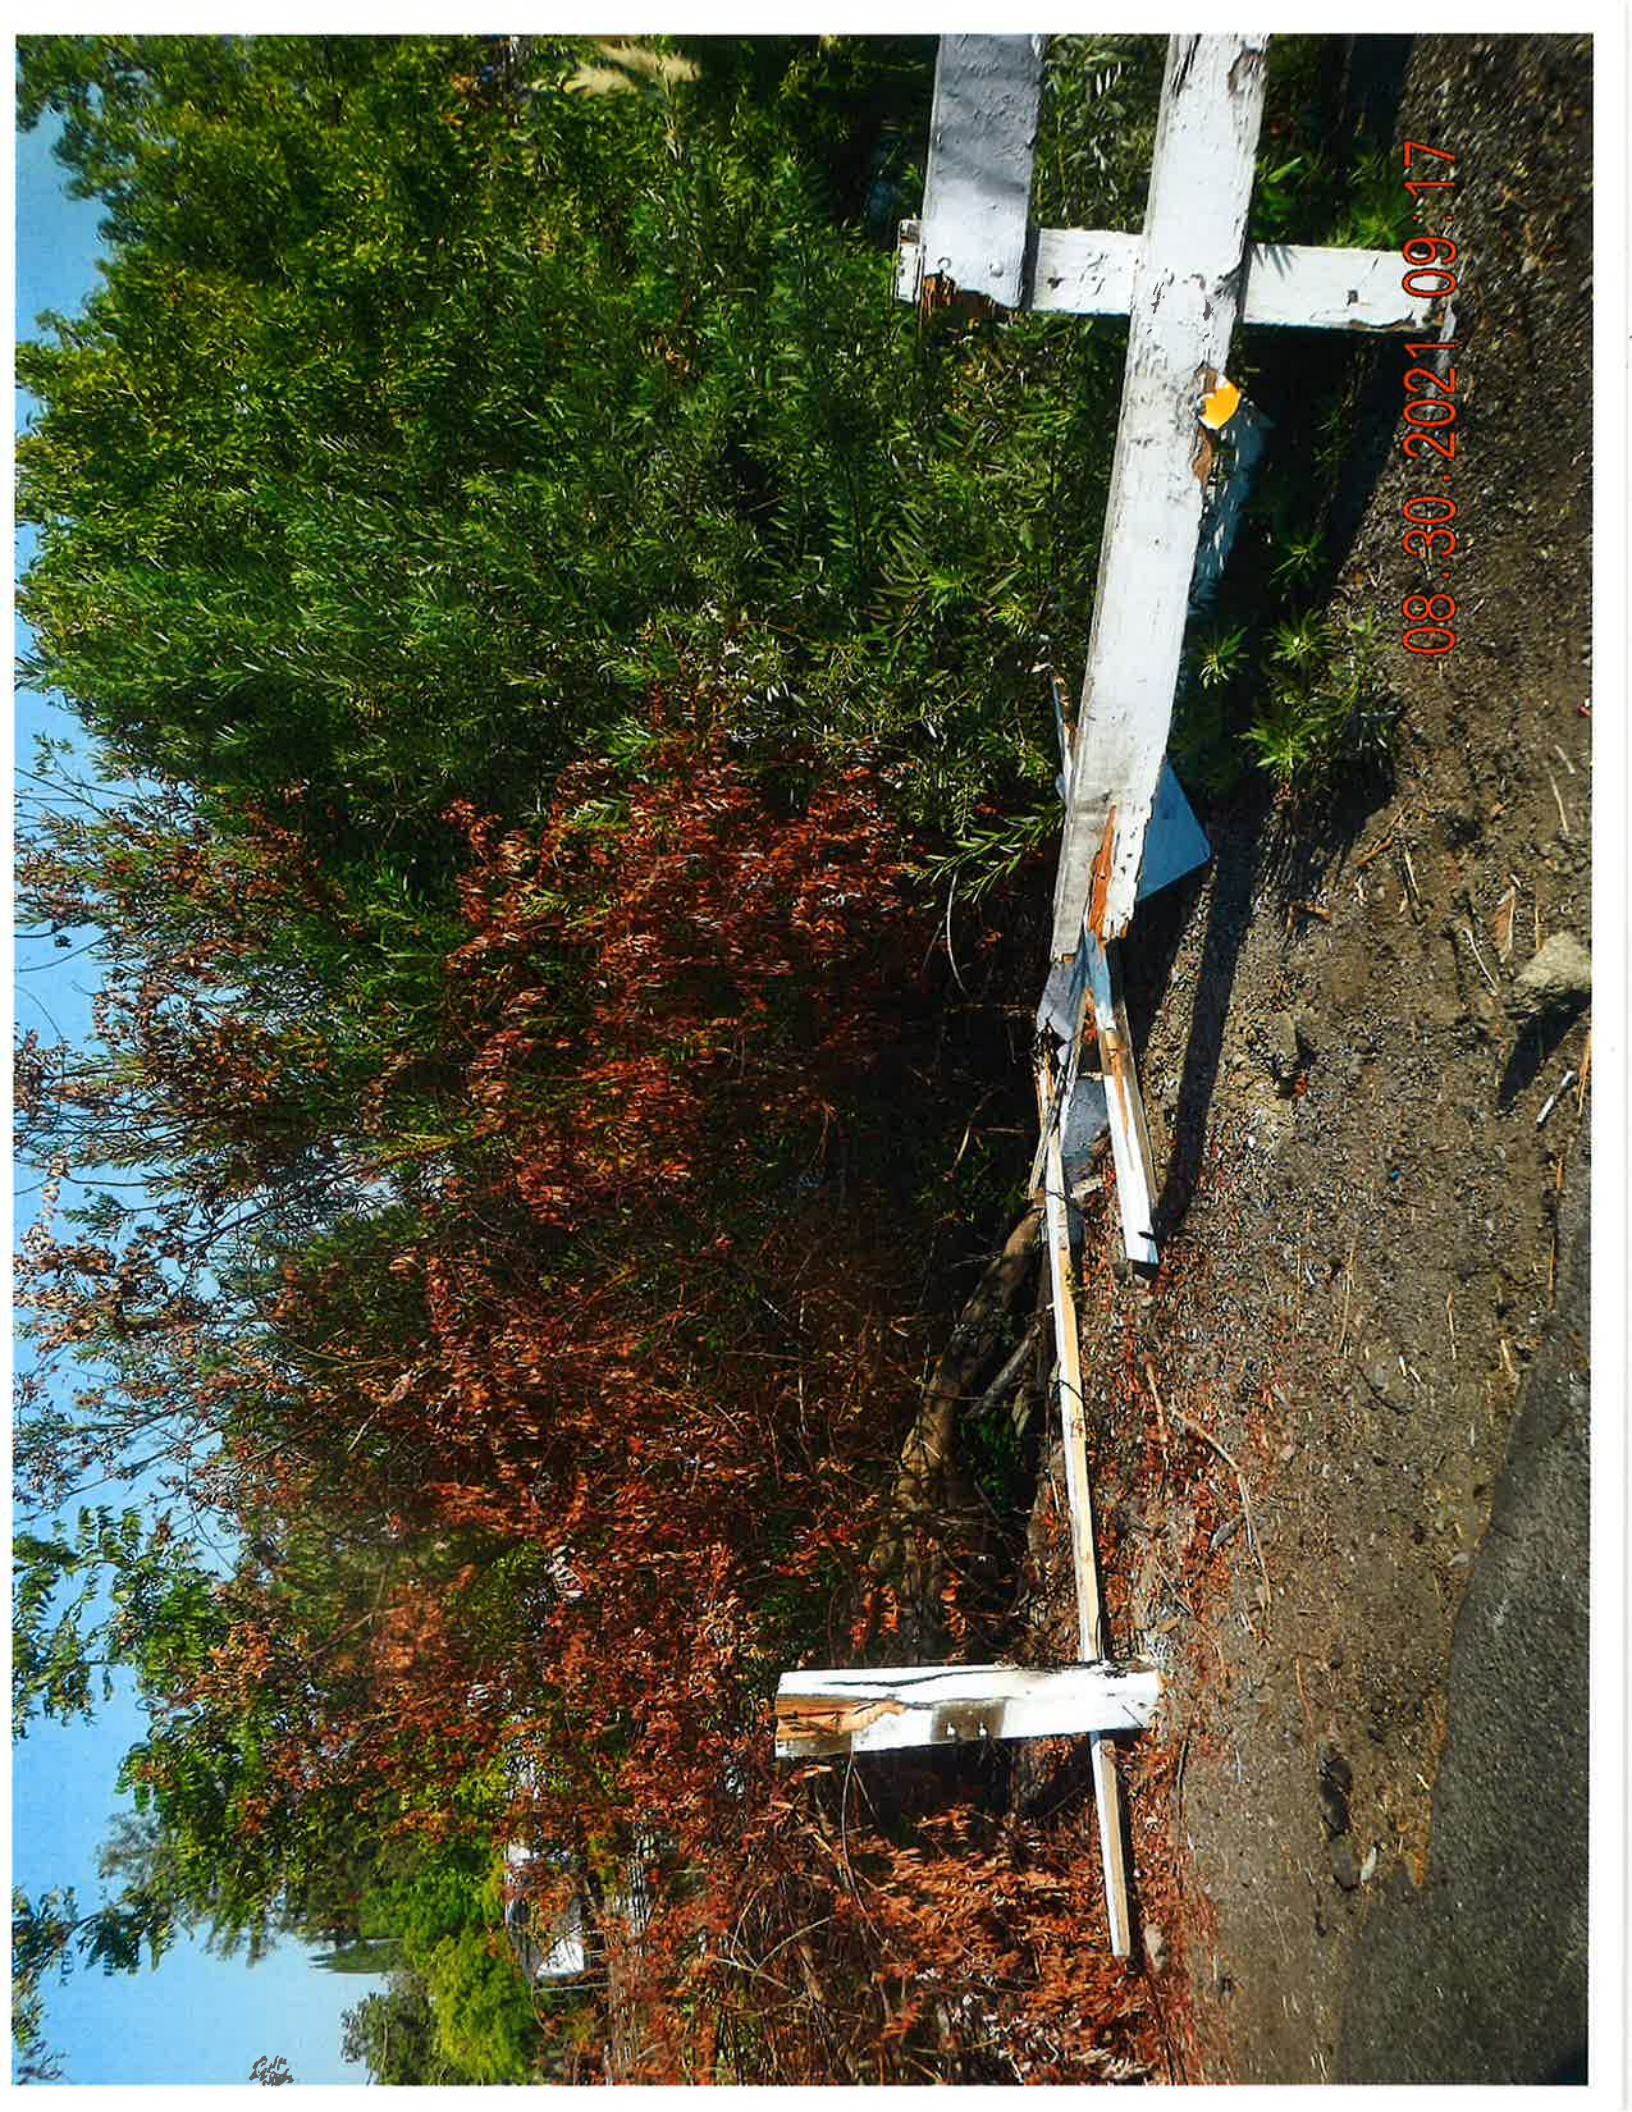
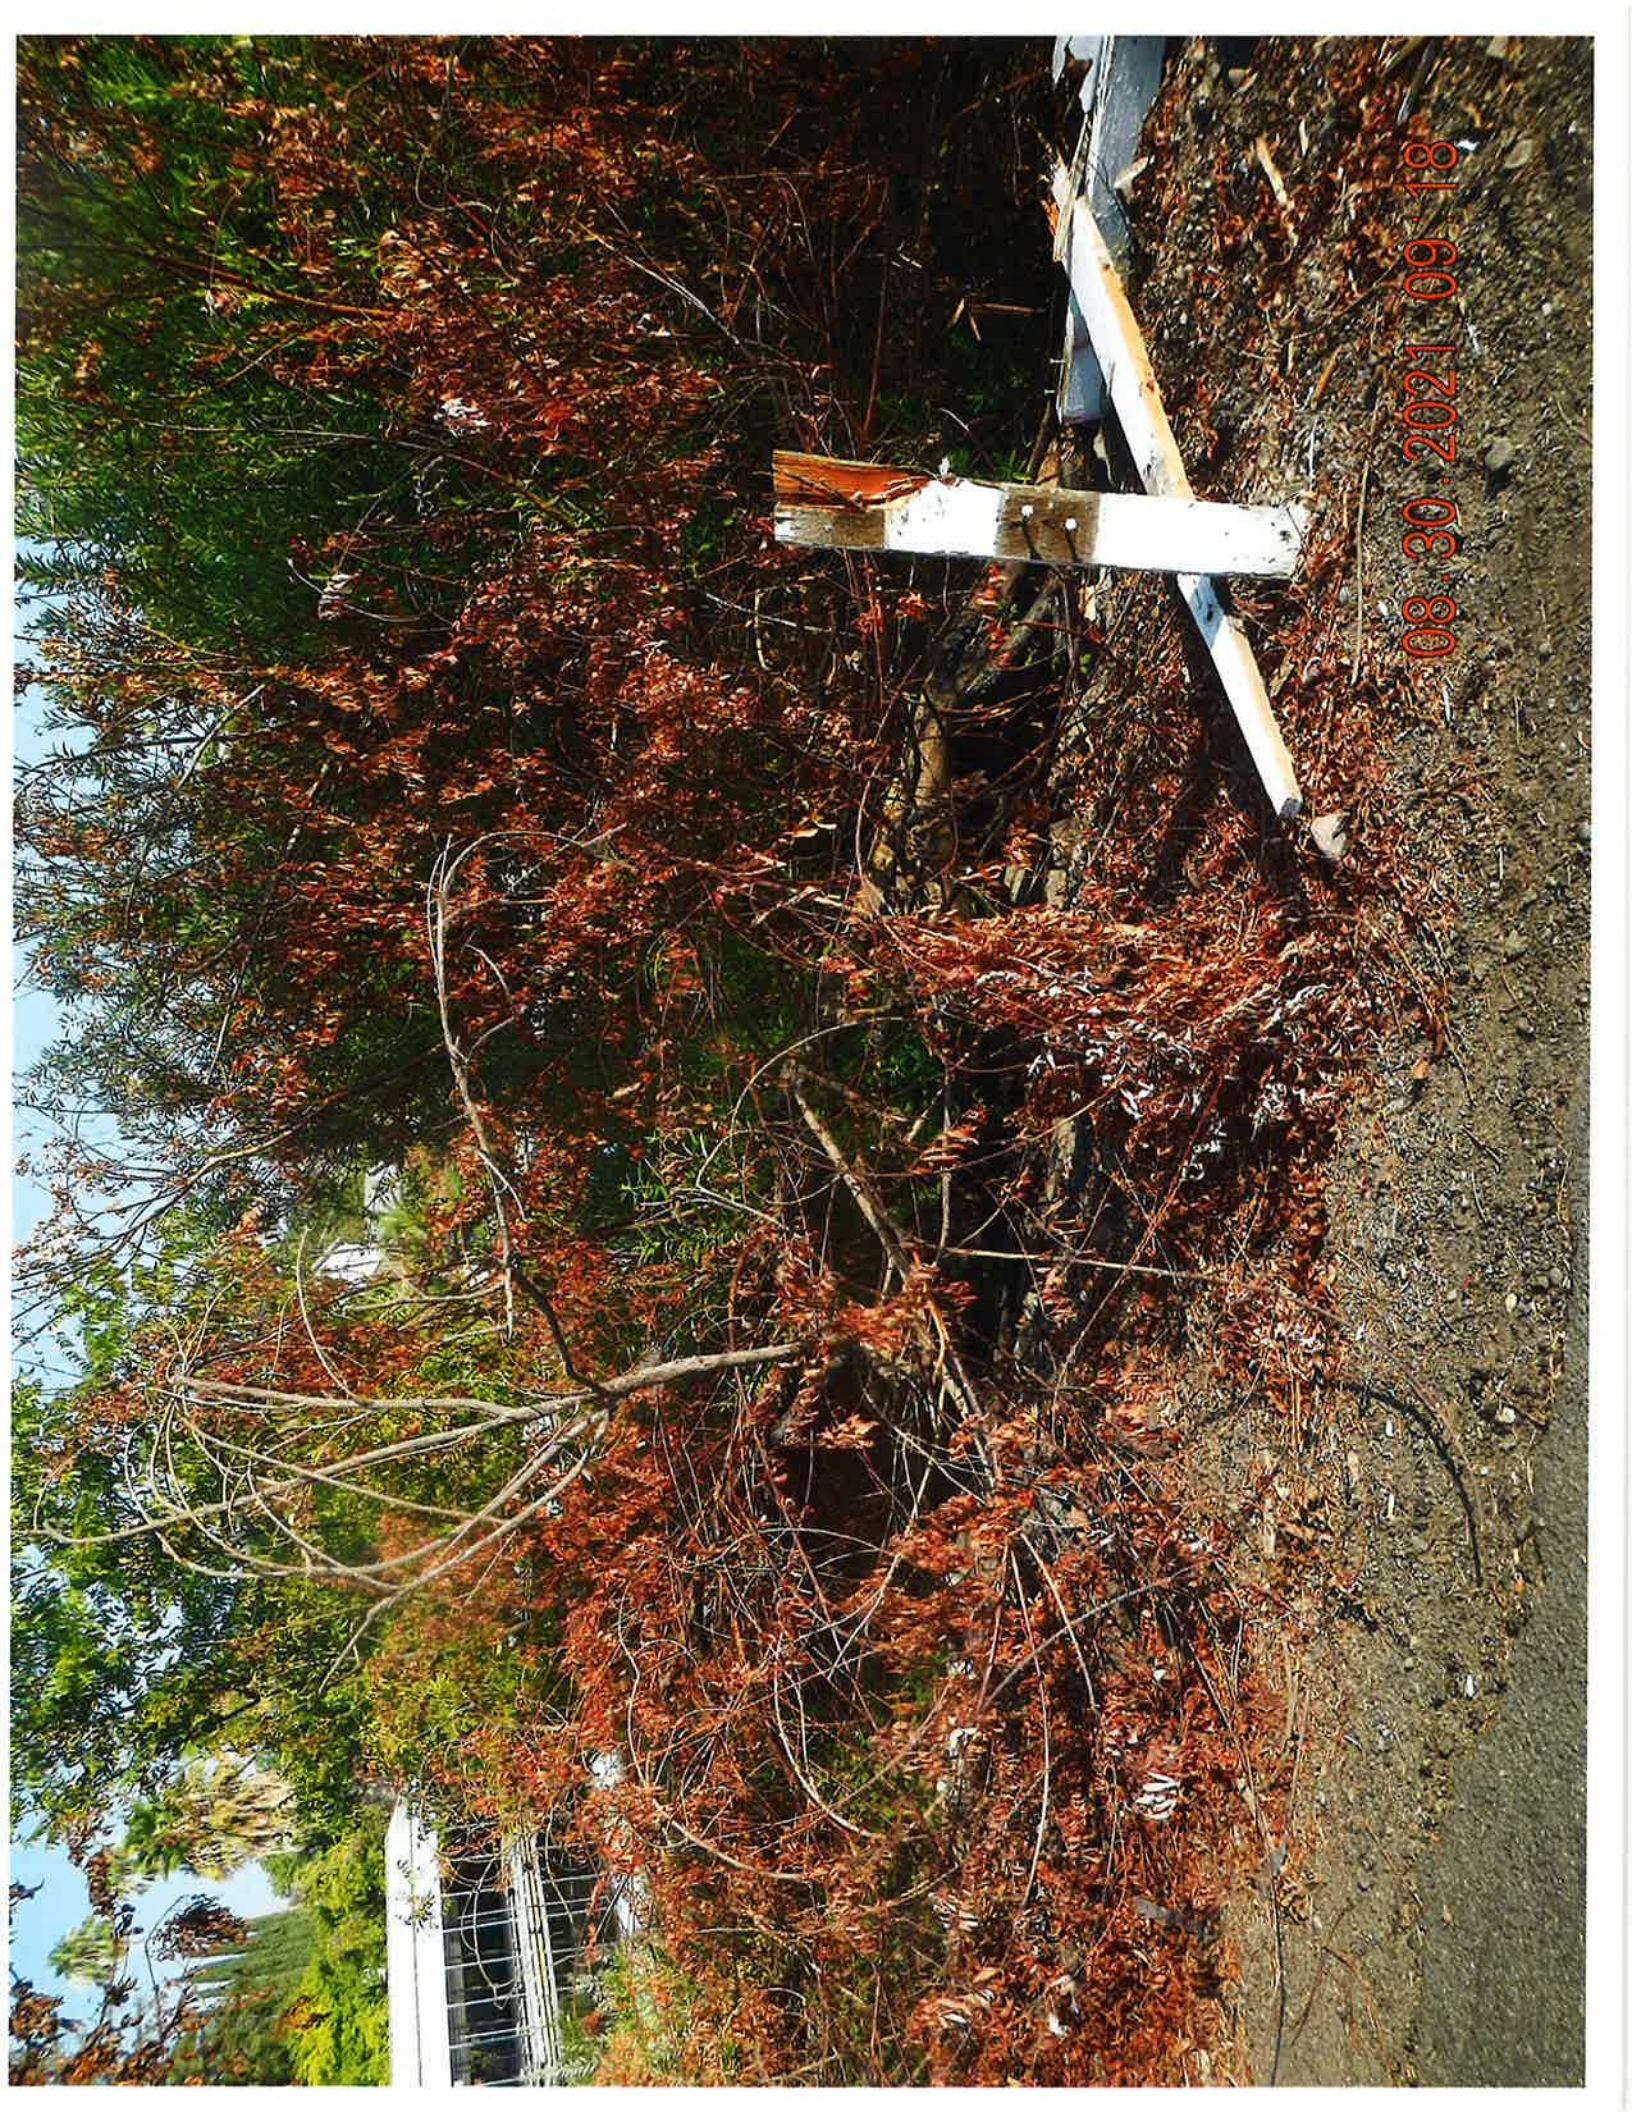
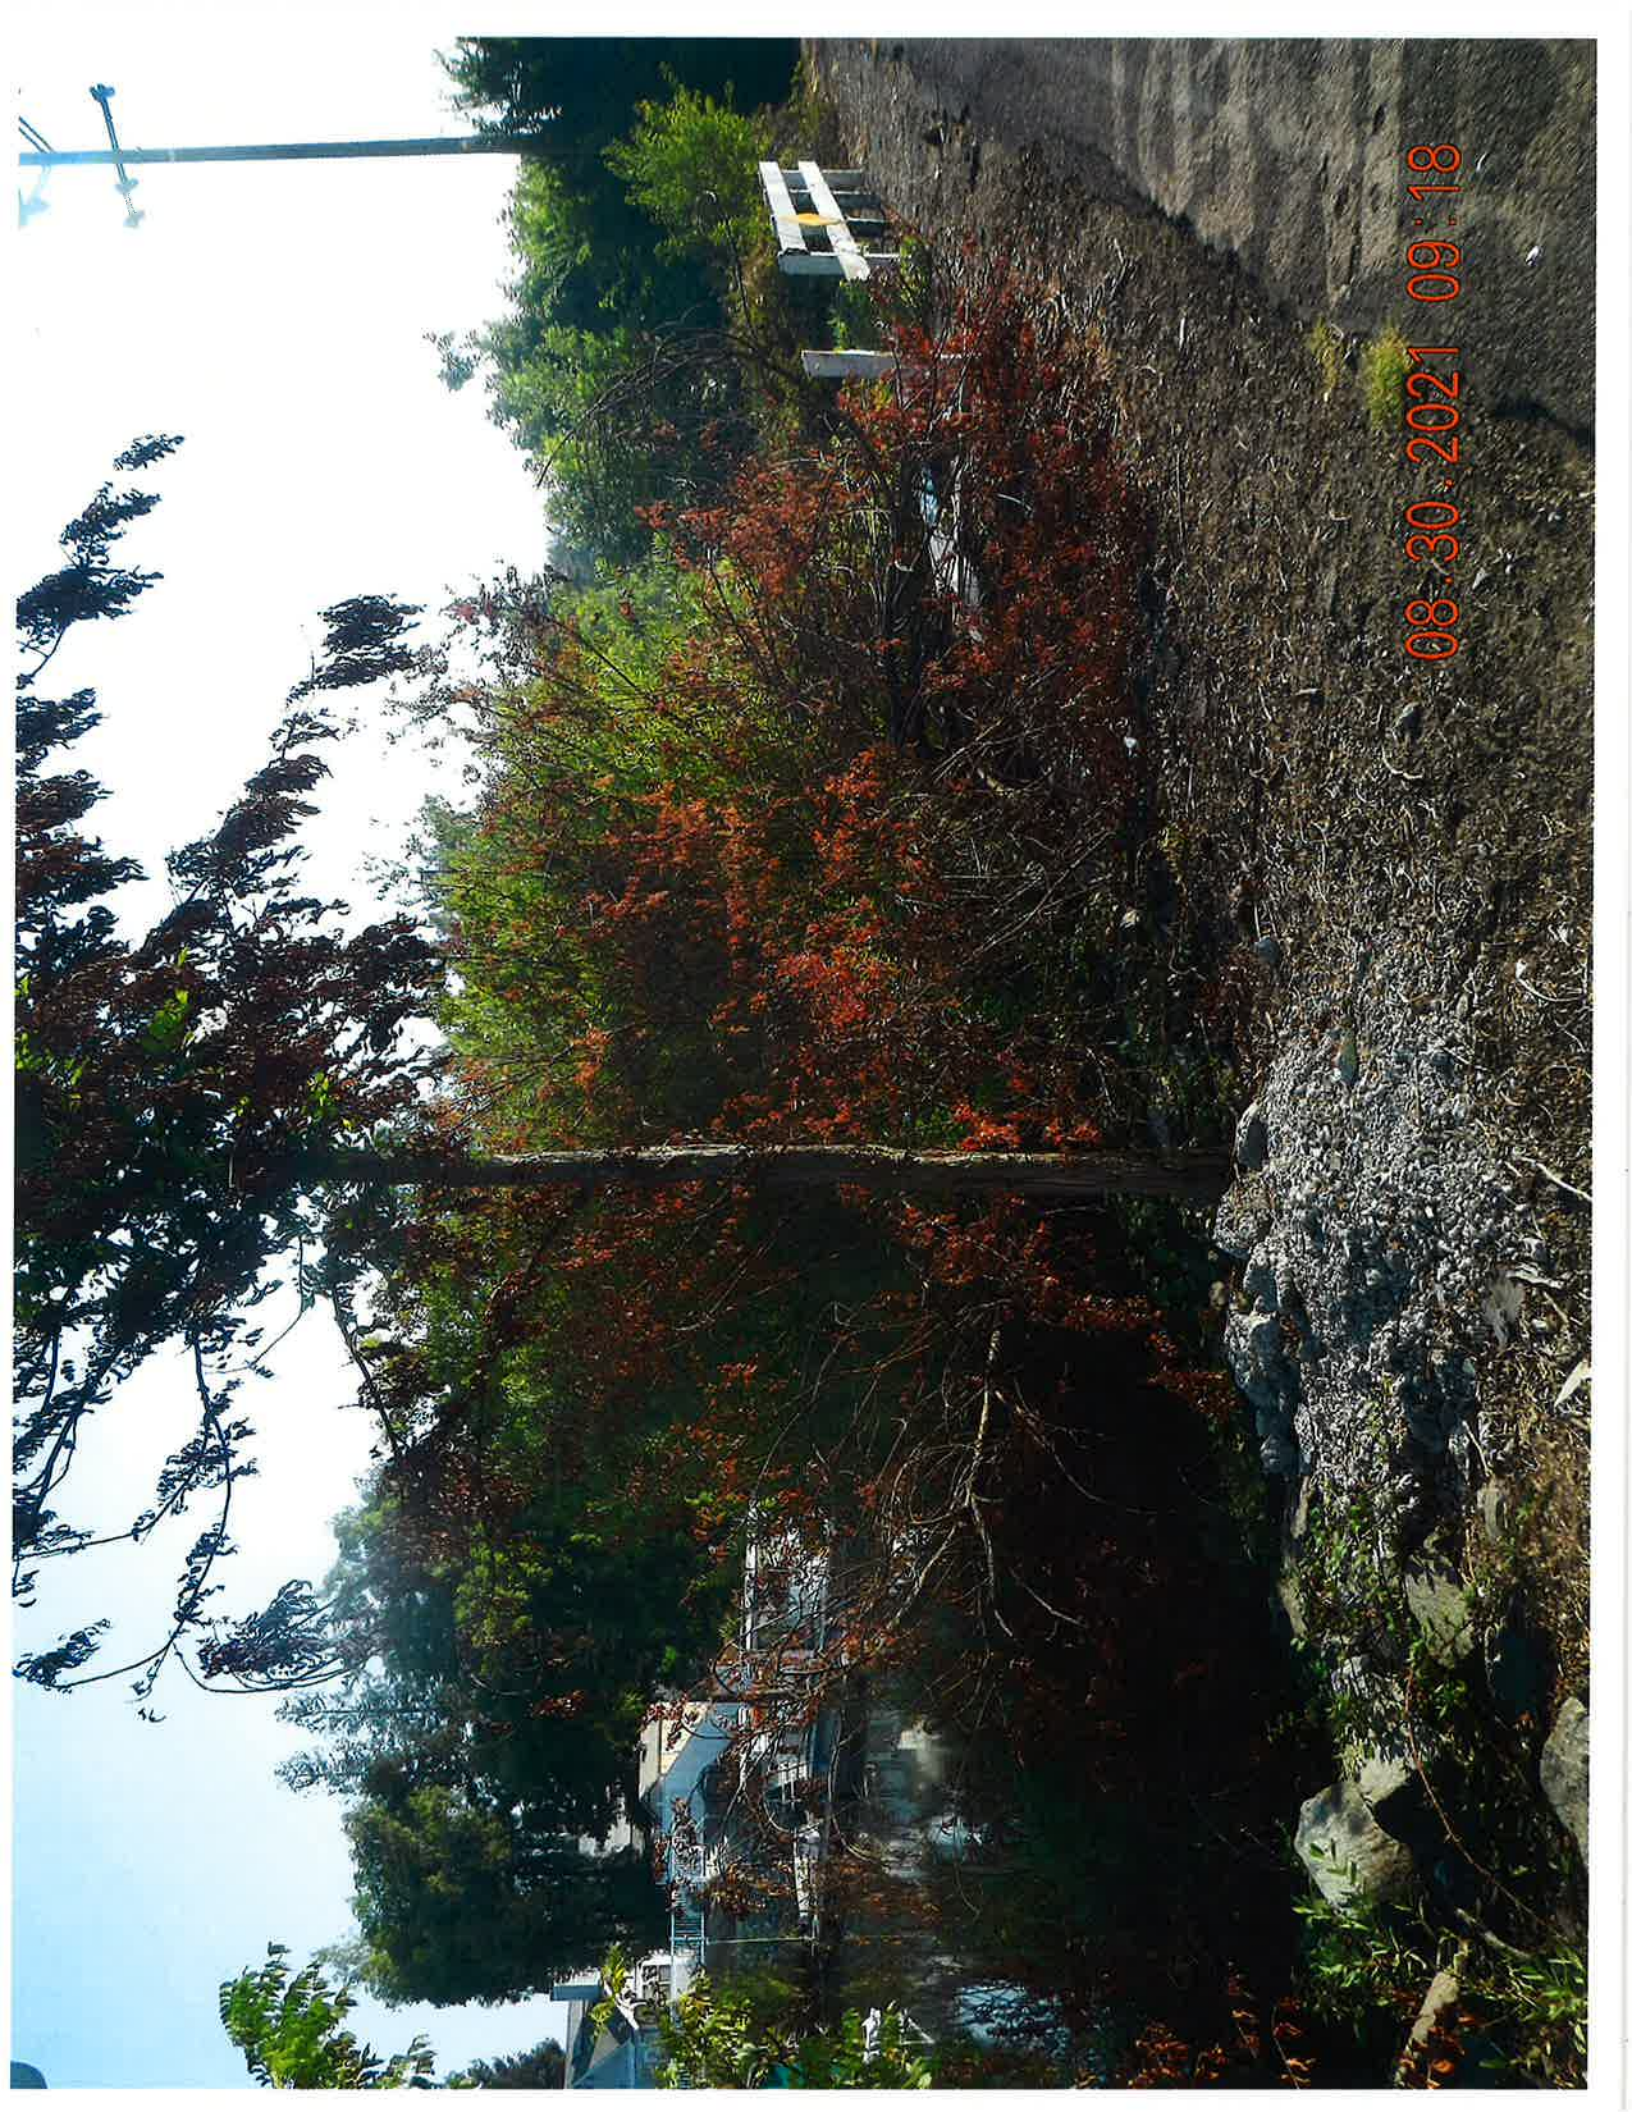
- Upon arrival at the area of Shimizu Drive and Wilshire Drive at the levee area, I observed a tree and the immediate surrounding area that was subjected to a fire. The tree was scorched, and the surrounding immediate area was burned at the ground level area. In addition, the dead-end road fencing on the water side hinge point of the roadway was damaged from an apparent vehicular accident.

- A review of the district levee area revealed that trimming of the hanging tree canopy and tree sapling removal services is needed. There is no significant levee vegetation except for a few areas of Arundo that need herbicide spraying.

- I took photos of the areas subjected to recent fires and areas of the levee showing vegetation control needs. See them in the project folder.
