**RECLAMATION DISTRICT NO. 828
WEBER TRACT
BOARD OF TRUSTEES MEETING
THURSDAY, OCTOBER 21, 2021
8:30 AM
ENGINEER'S REPORT**

FIELD REPORT

OWNER: **Reclamation District No. 828** PROJECT: **Vegetation Control Needs**
CONTRACTOR: **Dino & Son** CONTRACT NO.: [Click here to enter text.](#)
KSN JOB NO.: **1204-9022-04** DATE: **08/30/2021**

OWNER: **Reclamation District No. 828** PROJECT: **Man-Made Boat Ramp**
CONTRACTOR: **n/a** CONTRACT NO.: **n/a**
KSN JOB No: **1204-9022** DATE: **7/20/2021**

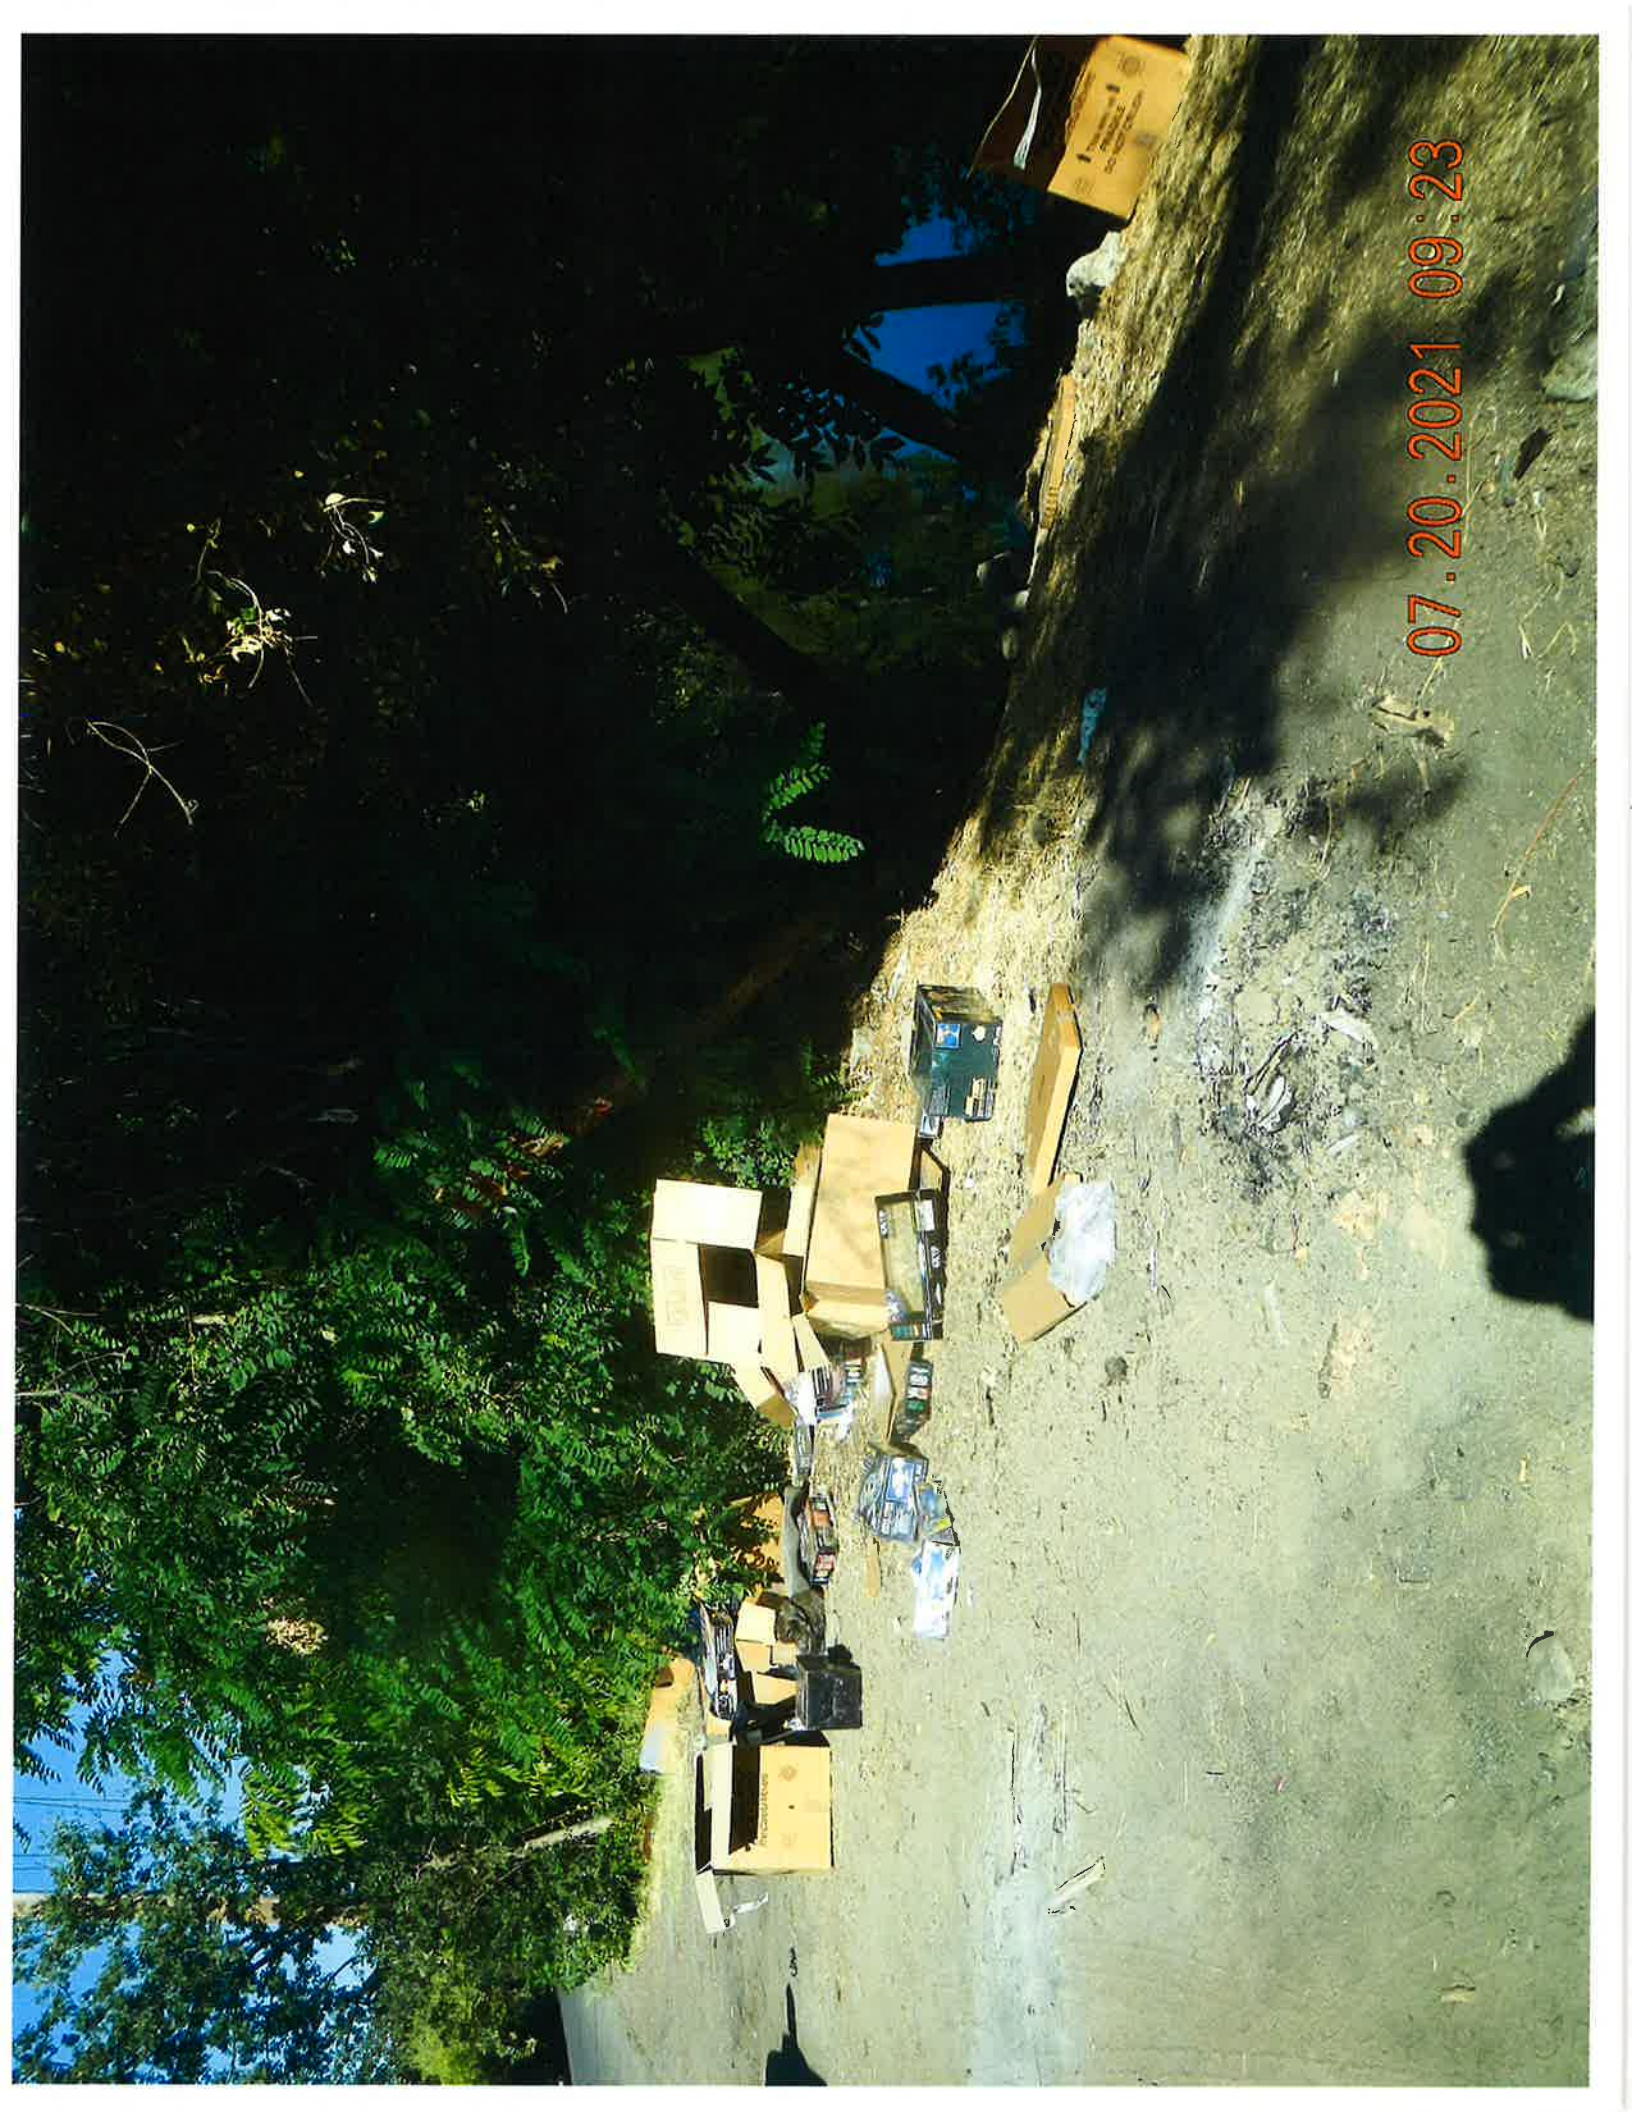
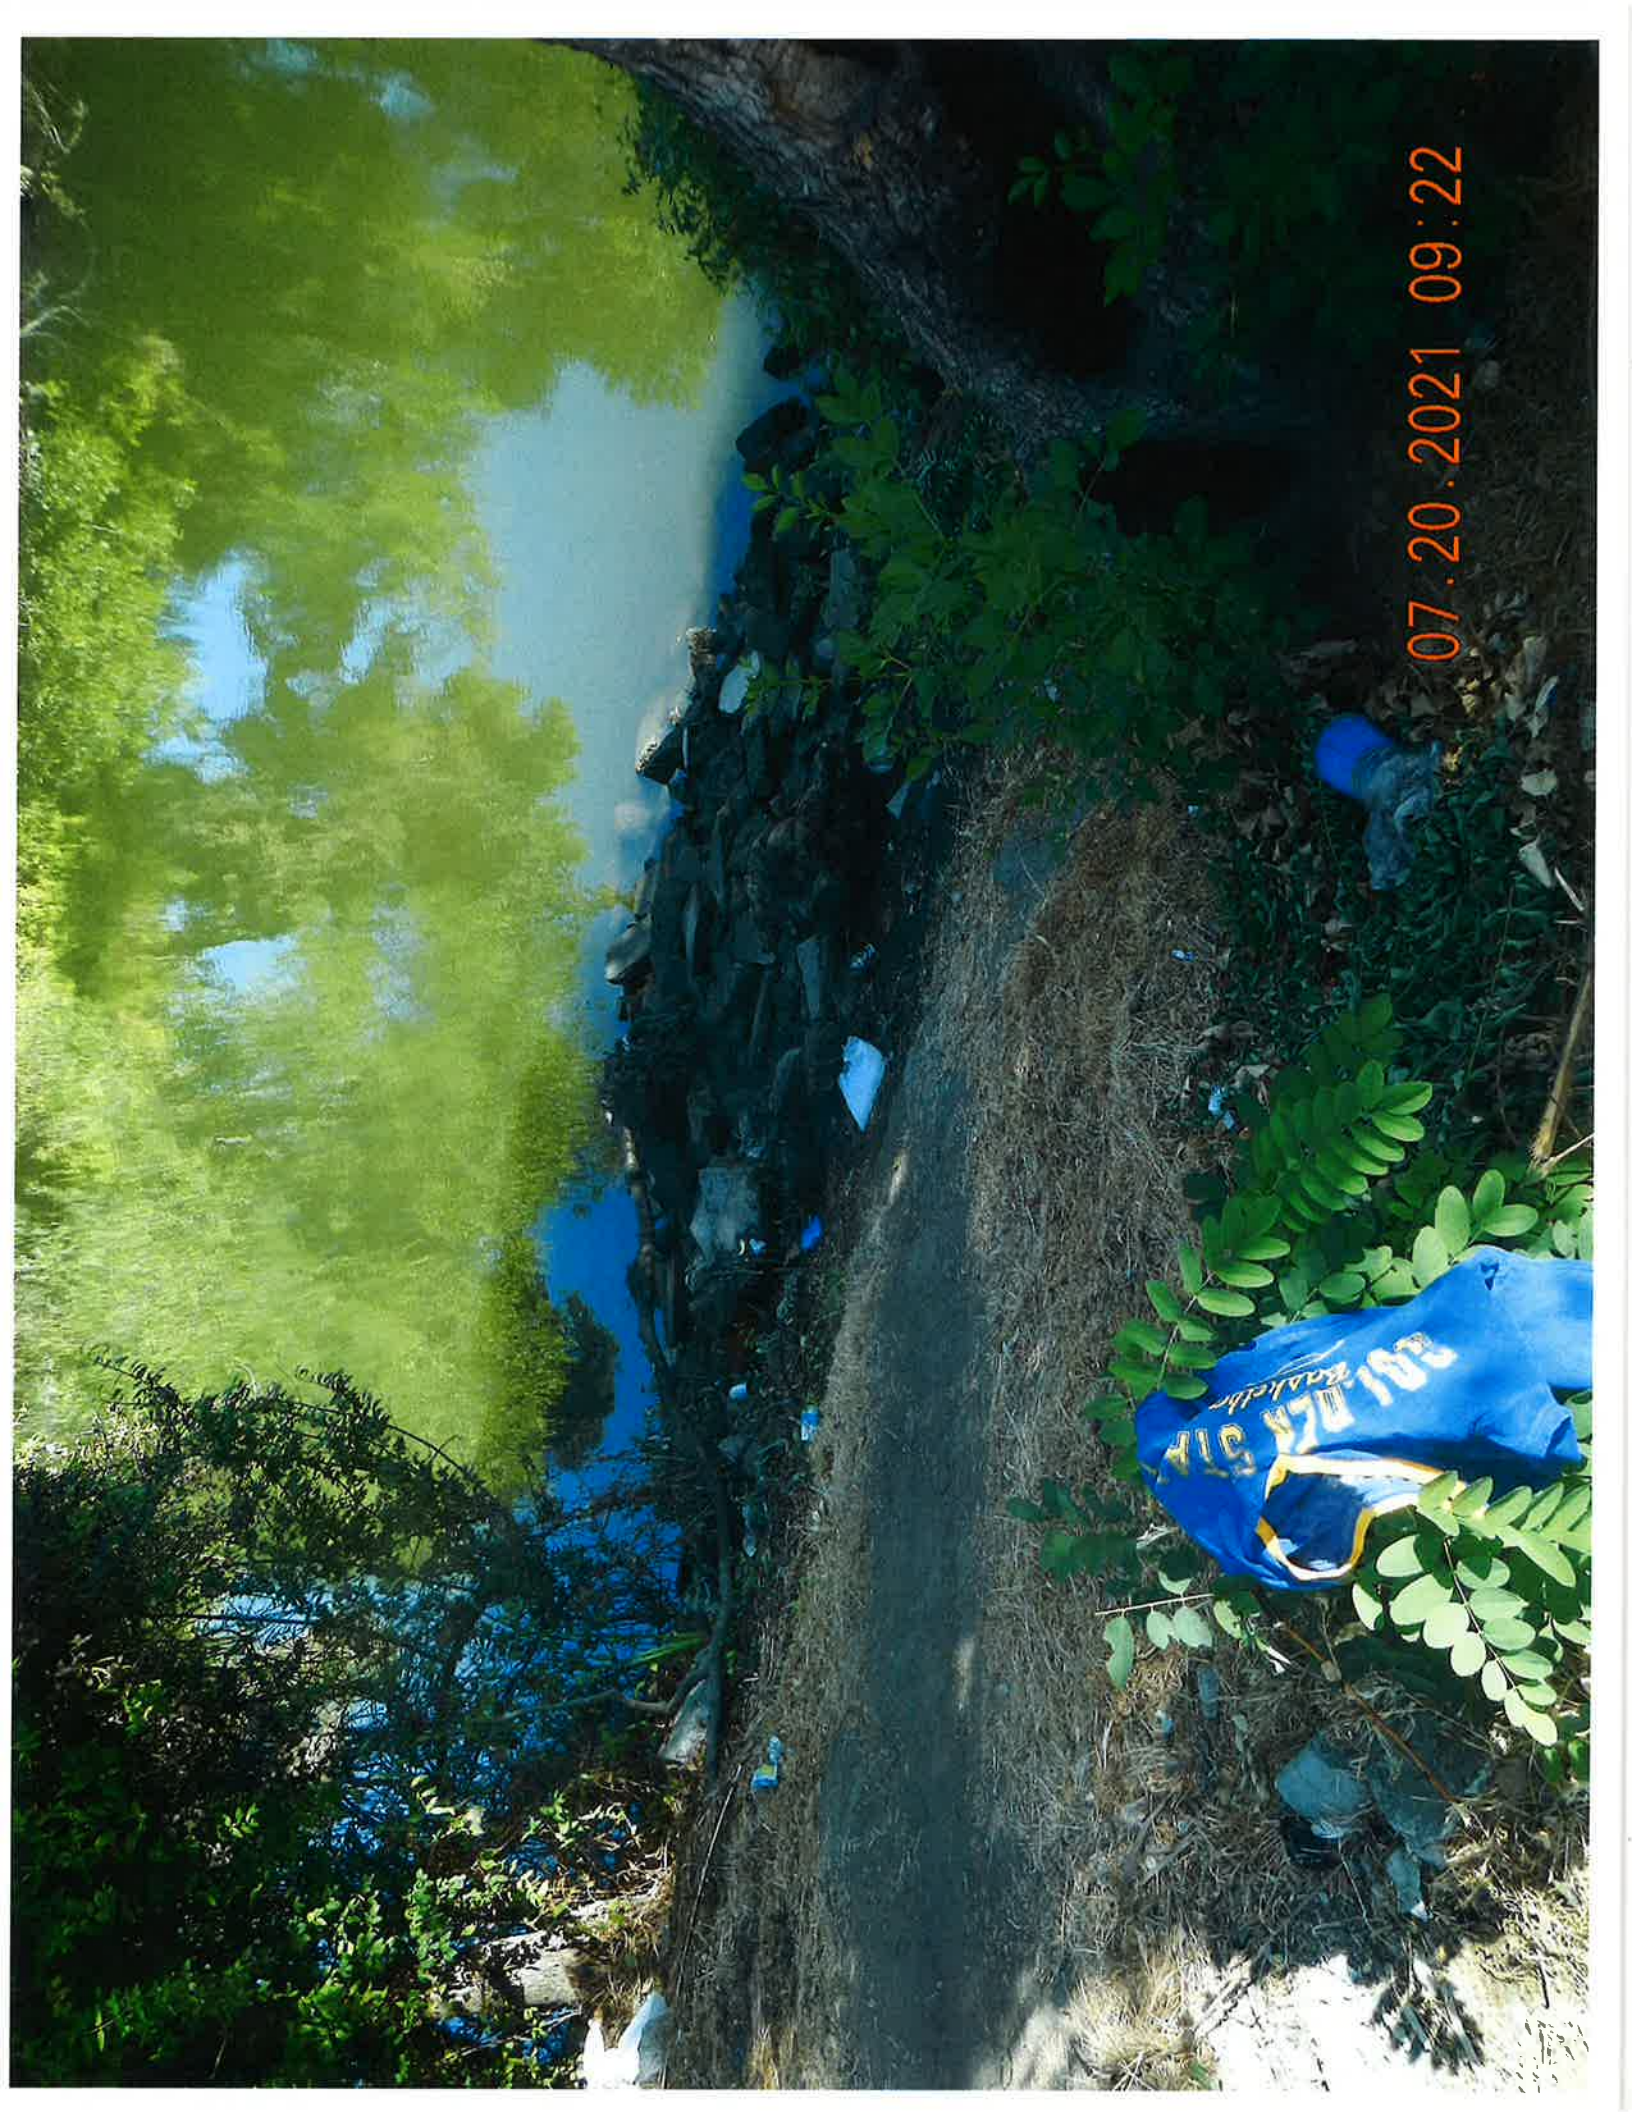
1. Upon observations, the levee slope did not have any existing damage. However, there was concrete rubble that was placed at the water side toe of the levee at and in the canal.
2. There existed a significant amount of garbage that was dumped at the site.
3. See photos of the existing conditions.
